POPPLETON HISTORIC STUDY

B-2734

<u>Block</u>	<u>Lot</u>	<u>Address</u>
250	58-71A	100-128 S. Arlington Avenue

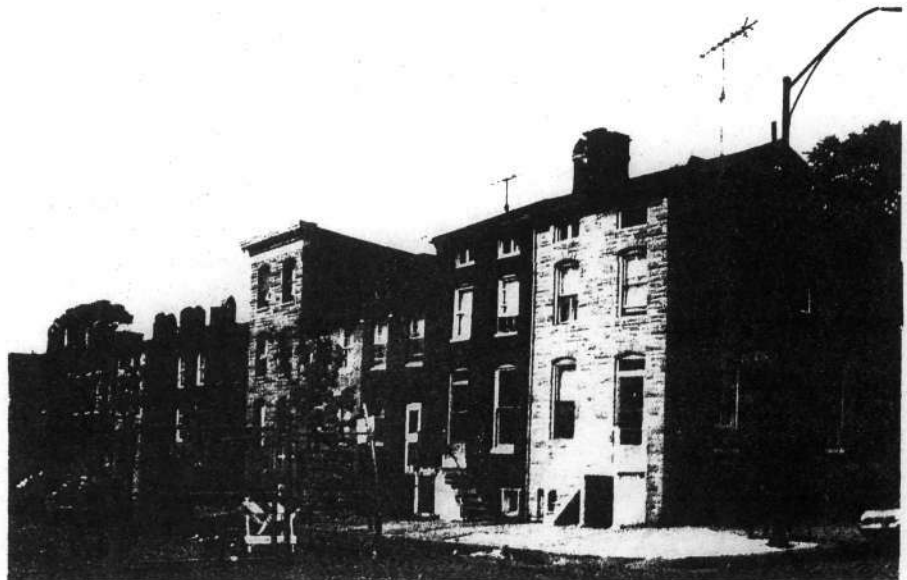
A good row, 2½ story gabled houses and 2 story houses. Number 126 has a hipped roof. Numbers 106, 110 and 112 have 6/6 windows; 100, 108, 114 and 126 have been formstoned. The group is carefully and lovingly maintained; the block should be protected.

Number 124 is vacant, there are no gaps. Street is torn up for expressway work and is not scheduled for reopening until late 1976 or 1977. Street is wide but not busy for it dead-ends at Pratt into the B. & O. shops. Street trees need feeding.
